GOOD VS BAD COATINGS

Evaluation of coating quality at Thermaspray (Pty) Ltd

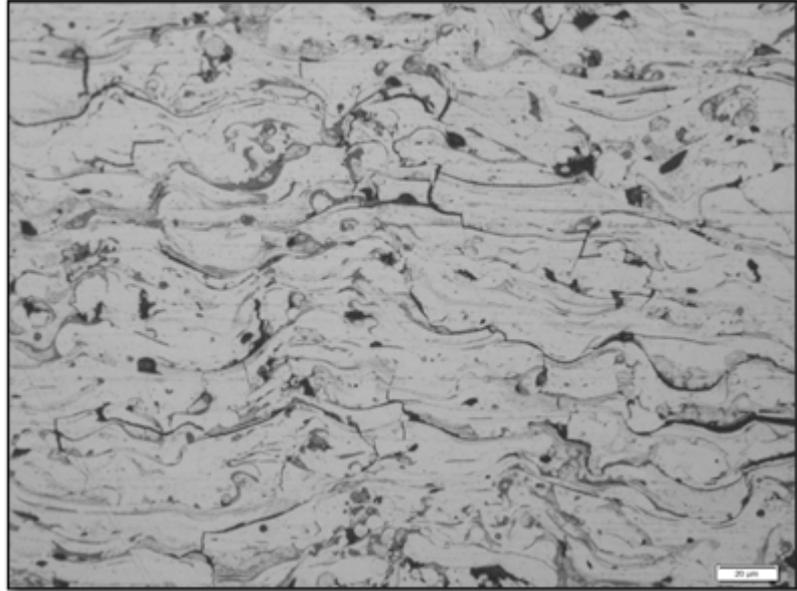
- Oxide inclusions appear as dark, elongated phases that appear as strings in the coating parallel to the substrate (Figure 5). These oxide inclusions lead to the added hardness of the coating.

This increase in hardness leads to brittle coatings as oxides fracture easily. If these strings are too concentrated this will lead to a decrease in cohesive strength of the coating.

Figure 5: Oxides in the coating

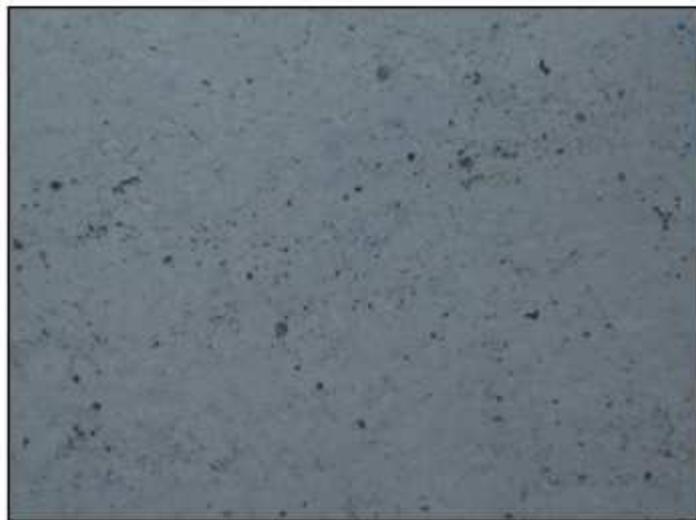
- With its dedicated metallurgical laboratory and staff, Thermaspray adheres to strict standards in its coating process and quality evaluation. Figure 8 shows a microstructure of a Thermaspray coating showing no crack, unmelted particles, oxides, and minimal porosity.

Figure 8: Thermal spray coating micrograph with no defects and minimal porosity

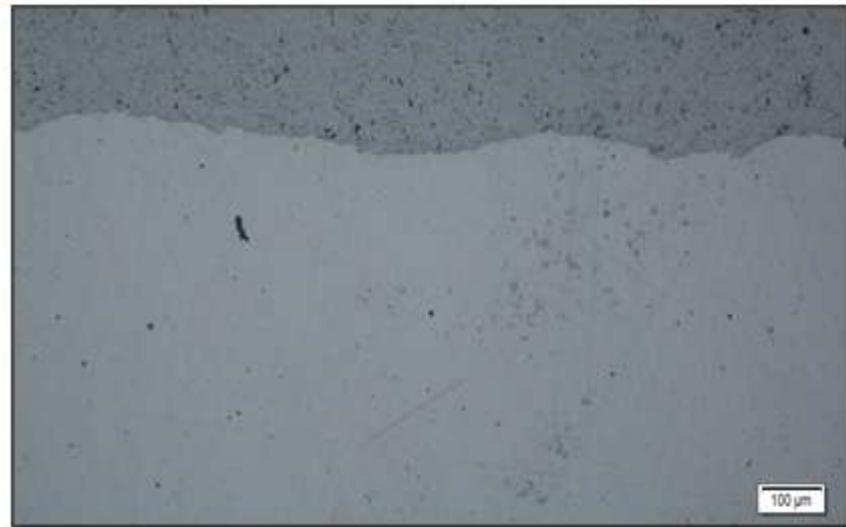
- Figure 9 below shows a good coating quality with low porosity and the absence of flaws. It also shows no grit entrapment, ensuring maximum adhesion to the substrate.

Figure 9: Coating micrograph with no grit entrapment and low porosity

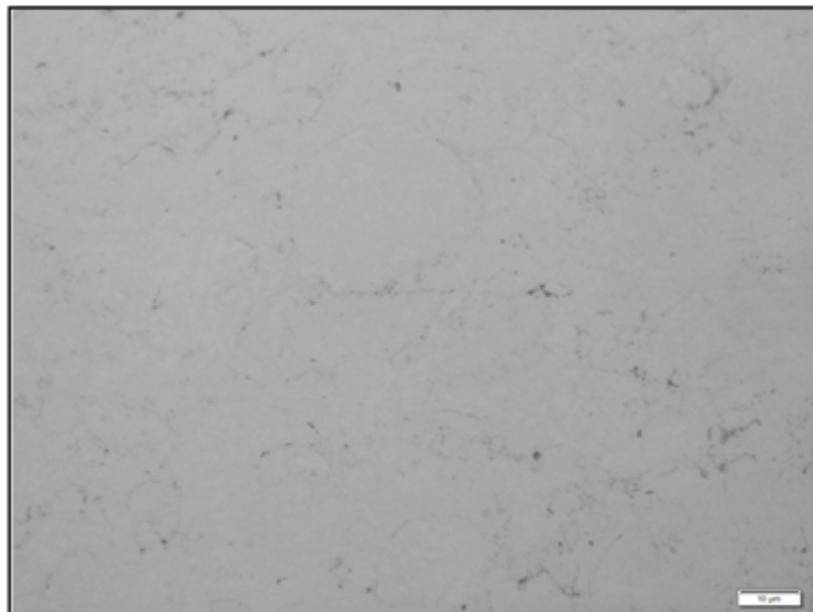
- Figure 10 again shows a coating with low porosity and the absence of flaws.

Figure 10: Coating micrograph with low porosity and no defects
