THERMASPRAY

Myth Buster 2

“Thermal spray coatings always chip off”

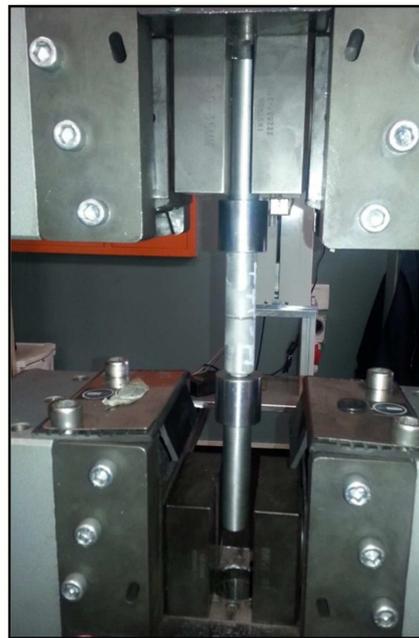
Figure 1: Adhesion samples in testing configuration

The adhesion of the coating is not solely dependent on the coating-substrate interface, but also on the bonding between the spray particles. The two main types of coating failure are cracking and de-bonding. The characterisation of thermal spray coatings through the use of measurement methods like the adhesion test (in accordance with EN 582 / ASTM C633) and the micro indentation test (Figure 1) defines coating quality.
